Manhole Inspection Summary

Manhole # S37EE1024MH

Insp Date: **4/18/07 1:58 PM**

Location Address: **3701 CHECTNUT HILL RD**

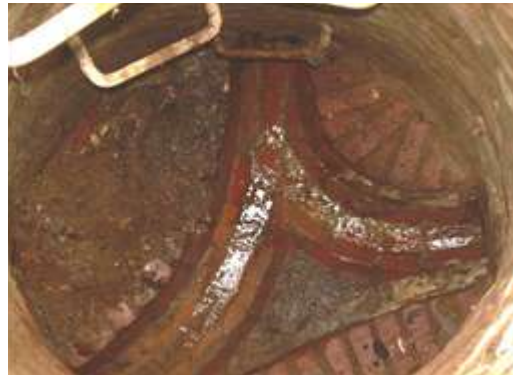
Top View

Corroded steps. Bench debris.

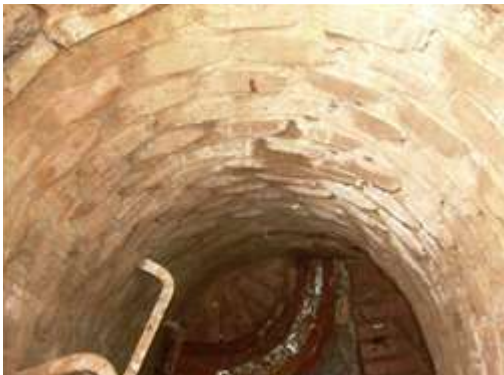
Defect

Frame leaks. Adjustment deterioration and infiltration. Corbel and Barrel infiltration.

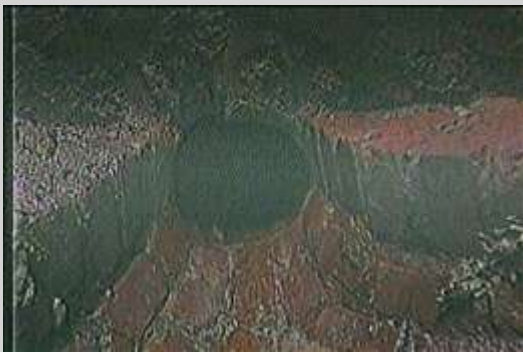
8 in. Circular Gravity Sewer Pipe Out @ 12 O'Clock

Barrel deterioration and infiltration. Channel deterioration.

Infiltration: **Evidence** Pipe Seal Cond: **Broken**

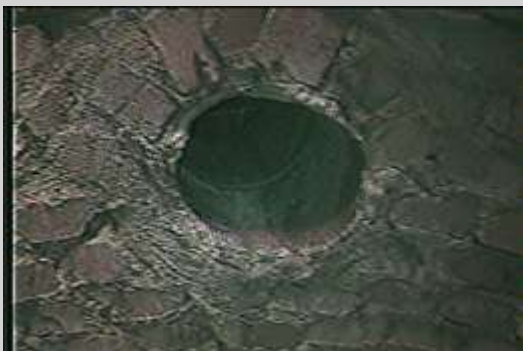
8 in. Circular Gravity Sewer Pipe In @ 3 O'Clock

Barrel deterioration and infiltration.

Infiltration: **None** Pipe Seal Cond: **Broken**

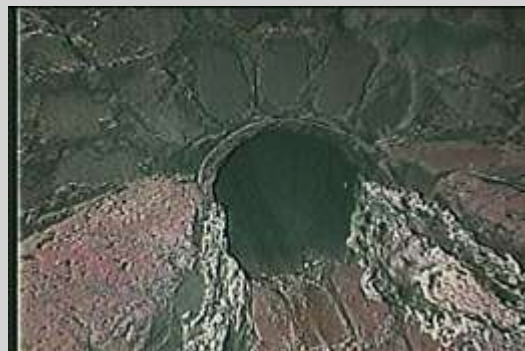
Drop In @ 3 O'Clock

Barrel deterioration and infiltration. Channel deterioration.

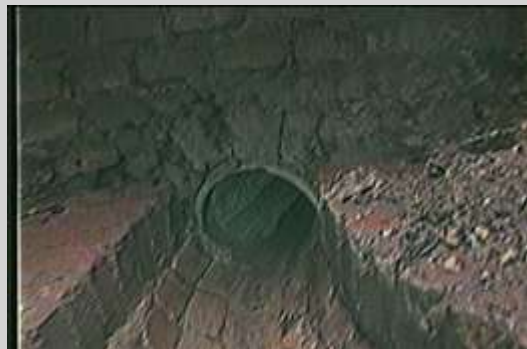
Pipe In @ 7 O'Clock

Barrel deterioration and infiltration. Channel deterioration.

Pipe Seal Cond: **Cracked**
